## Self-healing coatings: an alternative route for anticorrosion protection

Valérie Sauvant-Moynot, Serge Gonzalez, Jean Kittel

IFP Lyon – BP3 – 69390 Vernaison (France)

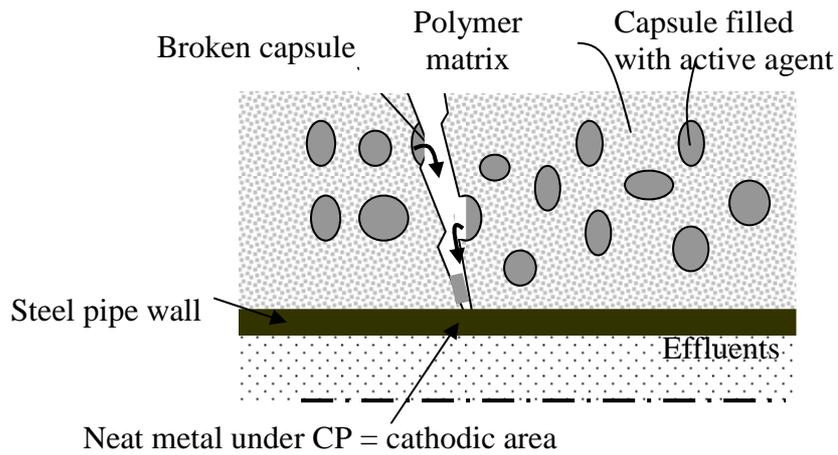
Figure 1 – Schematic illustration of the function of an organic pipe coating containing microencapsulated specific film-former agents sensitive to electrical field and pH encountered in the vicinity of cathodic areas.

In the present study, attempts were made to develop improved self-healing coatings dedicated to the anticorrosion protection of metal structures under cathodic protection. Based upon the information described above, emphasis was on assessing the potential of novel self-healing agents to be microencapsulated. Specific film-formers under investigation [22] were selected and developed for their sensitivity to both the electrical field and the alkaline pH encountered in the vicinity of a defect on a coated structure under cathodic protection (Figure 1):

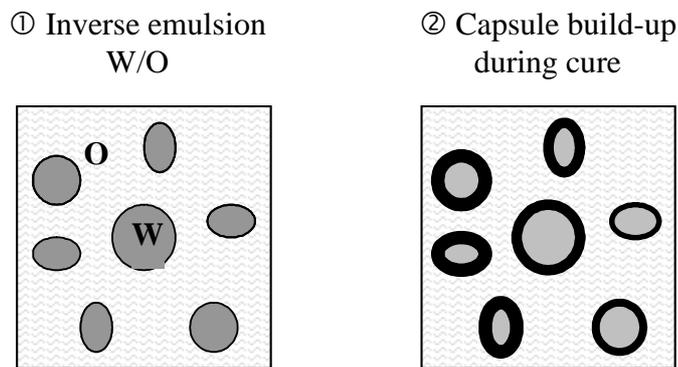
Figure 2 – Encapsulation of the inorganic agents by interfacial reaction in inverse emulsion.

Epoxy-amine microcapsules were prepared by interfacial reaction in inverse emulsion as illustrated in Figure 2. An aqueous solution was prepared by mixing 2 g of  $\text{MgSO}_4$ , 3 g of aliphatic diamine monomers (HY2954 from Huntsman) and 0.2 g of imidazole catalyst in 15 g water. 0.2g of acetic acid was added to maintain the solution homogeneous with a pH around 8.5 [26]. An organic solution was prepared by solving 9.8 g of Diglycidyl Ether of bisphenol-A (LY556,  $M_w = 380$  g/mol purchased from Huntsman) and 1 g of emulsion stabilisator in API fuel (T boiling =  $250^\circ\text{C}$ - $350^\circ\text{C}$ ). Then the water based solution was added to the organic solution at room temperature under thorough stirring (500 rpm), forming a stable inverse emulsion (water in oil). Interfacial reactions between resin and hardener monomers dissolved in stoichiometric composition were allowed to occur by heating the inverse emulsion to  $80^\circ\text{C}$  during 20 minutes under continuous agitation. Then mixture was cooled to room temperature and 1.4 g of microcapsules were collected by a first filtering, corresponding to 4.5 % output in weight. In order to improve this result, 5 g of hydrophilic silica powder (Syloid ED3 from Grace) were added to the emulsion to ease the filtering of the capsules and avoid their agglomeration. 24g of microcapsules were collected by a second filtering, increasing the global output to 81.0 % in weight.

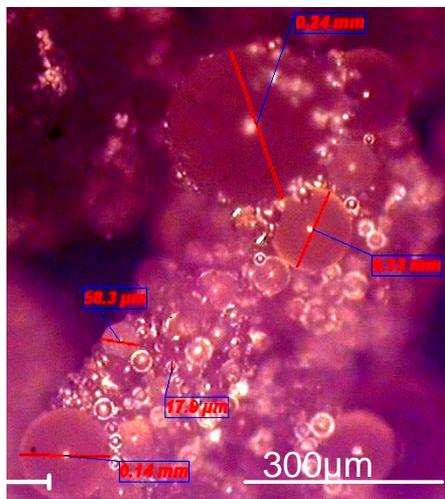
Figure 3 – Microcapsules formed by inverse emulsion in fuel API.

The obtained microcapsules were ranging in size from 10  $\mu\text{m}$  to 240  $\mu\text{m}$  diameter, as shown by optical microscopy observations (Figure 3). The thermo-gravimetric analysis revealed an average water content reaching 10 % in weight, according to the weight loss accompanying the 1 hour heating step at  $120^\circ\text{C}$  (Figure 4). Since  $\text{MgSO}_4$  was initially dissolved in water, one can estimate from the initial ratio of salt to water content that microspheres contain about 1.4 % of  $\text{MgSO}_4$ . The presence of  $\text{MgSO}_4$  in the encapsulated solution was confirmed after the calcination of microspheres in an oven at  $650^\circ\text{C}$  for 4 hours, washing of the inorganic residue by deionised water to dissolve the salt, filtering and precipitation of  $\text{BaSO}_4$  when adding a few drops of  $\text{Ba}(\text{NO}_3)_2$  concentrate solution. As a conclusion, the encapsulation process was successful but its efficiency may be improved in the future.

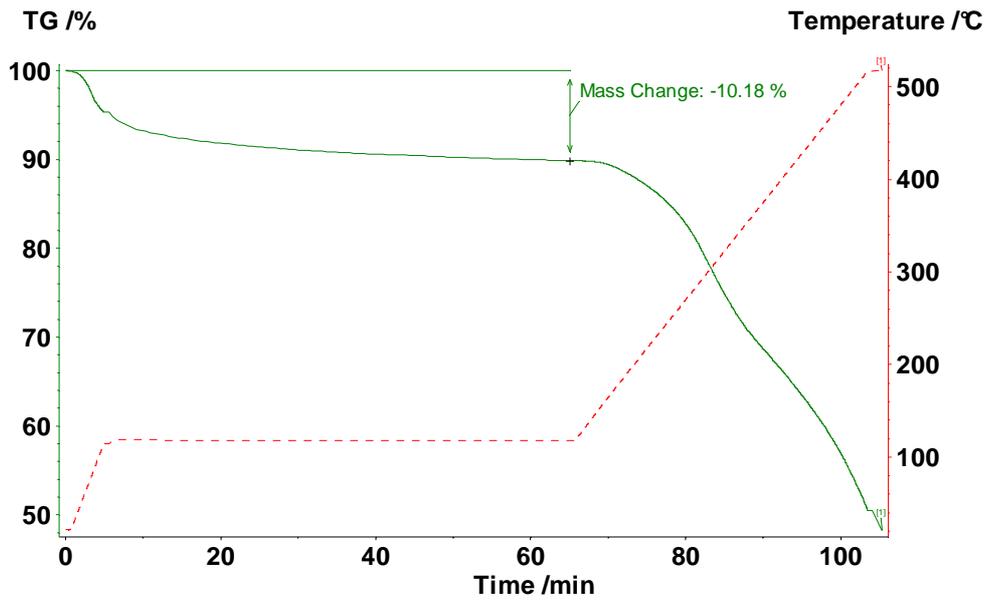
Figure 4 - Thermo-gravimetric analysis of microcapsules formed by inverse emulsion in fuel API.

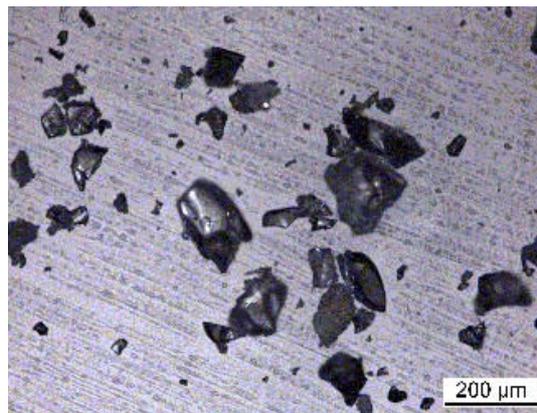
Figure 5 – Organic agent formed by drying the acetate adduct.

In this work, organic film-former agents were prepared by an original process avoiding the encapsulation stage. In a first step, epoxidised phenol-novolac polyepoxide resin (EPN 1138 from Araldite with an epoxy functionality of 3.6) solubilised in 2-methoxy ethanol (50 %, wgt.) was mixed with diethanol amine (DEtOA from Huntsman) in non stoichiometric proportions (1/1.7 moles epoxy/amine ratio). The mixture was allowed to react during 24 hours at 30°C to produce the epoxy functionalised EPN-tertiary amine adduct (water insoluble). In a second step, the adduct was neutralised by acetic acid to get a water soluble acetate adduct suitable for use in cathodic electrodeposition. In a third step, the acetate adduct was dried to evaporate water and a fine white and very brittle powder was collected. These organic grains with average diameter of  $30 \pm 10 \mu\text{m}$  (Figure 5) were thought to be very attractive for use as self-repairing fillers because they can be easily incorporated into a polymer matrix, avoiding the encapsulation step. When the grain's surfaces come in contact with water diffusing into a crack, hydration is expected to occur and allow the migration of the acetate adduct to the cathode, deposition and self-cure as previously described in equations 5 to 9.

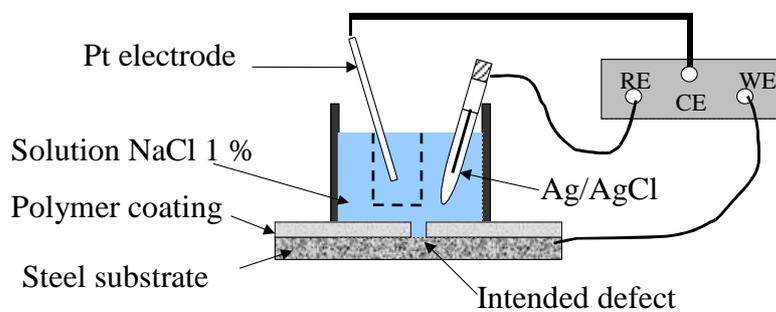
Figure 6 - Schematic of electrochemical cell used for the evaluation of the FBE coated plates under CP prior and after damage (a semi-permeable membrane is used to avoid the oxidation of chlorine ions in dichlore at the Pt electrode)

Coated specimens were placed in a glass cell as pictured in Figure 6. A 1 % (wt.) NaCl aerated solution was added and the sample was polarised at a potential ranging from -0.85 V to -1.5 V vs. Ag/AgCl//KCl(sat) reference electrode. On demand, an artificial defect was intended with a cutter in the centre of the coated panel (typical dimension of the defect were a few mm long and with a groove width taken equal to 200 $\mu\text{m}$ ). During the whole test period, the current demand for cathodic protection was recorded each 20 minutes. Periodic electrochemical impedance spectra (EIS) were also recorded throughout the entire testing. EIS measurements were done with a Gamry<sup>TM</sup> Instruments CMS 300 and a PC4/300 potentiostat. The scanning frequency range was from 100 kHz to 100 mHz with an imposed voltage amplitude of 100 mV (rms). Tests were carried out in isothermal conditions from 23°C up to 60°C to simulate the case of a coated pipe conveying warmer effluents. Exposed surface areas were ranging from 12.5 cm<sup>2</sup> to 75 cm<sup>2</sup>, depending on the coating thickness. In the case of intact coatings with high impedance, enlarging the exposed area to electrolyte is a method to keep a good sensitivity in EIS measurements for thicker coating (ISO 16773).

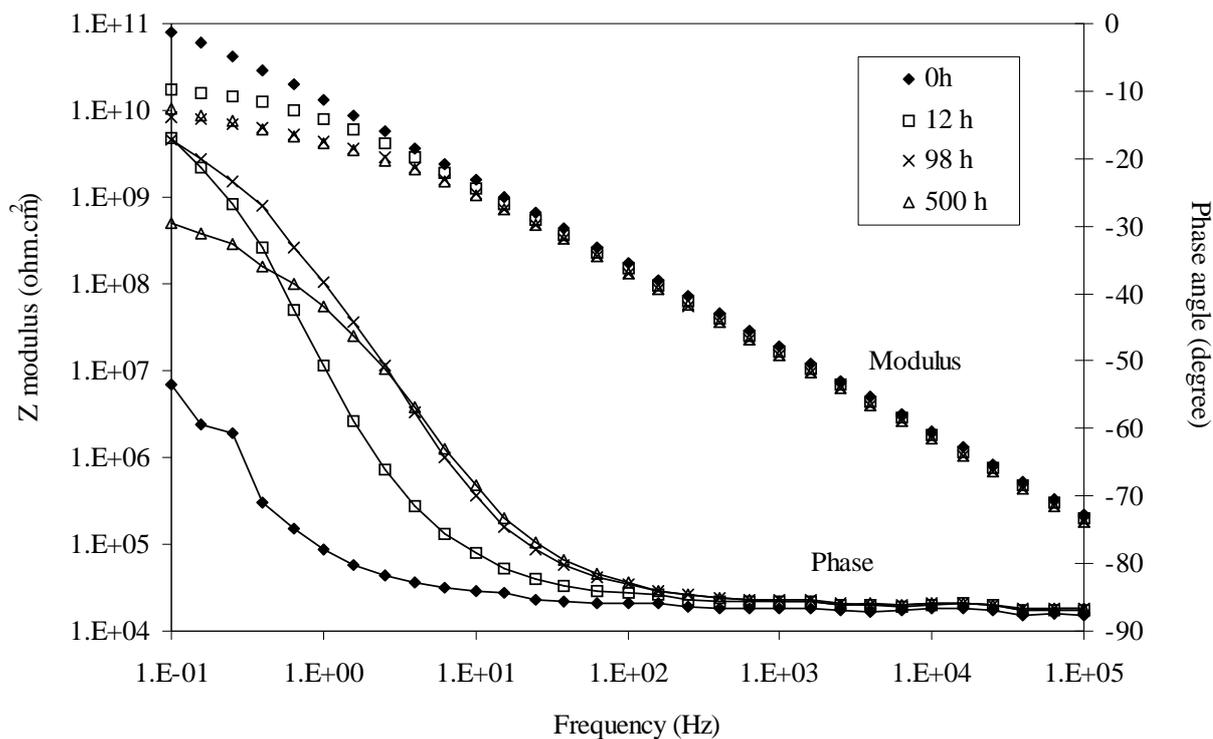
Figure 7 - Bode plots for the intact reference coating (DFT = 550  $\mu\text{m}$ , exposed area = 60.5  $\text{cm}^2$ ) immersed in a solution of NaCl-1 % at 40°C under cathodic polarisation (-1.1  $\text{V}_{/\text{Ag}/\text{AgCl}}$ ).

The behaviour of the reference coating has been investigated by EIS measurements performed on an intact paint (DFT 550  $\mu\text{m}$ ) during a few days immersion in NaCl-1% at 40°C under cathodic protection (-1.1 V/<sub>Ag/AgCl</sub>). The evolution of the impedance modulus and phase is plotted versus frequency on Figure 7 after 0, 12, 98 and 500 hours. Bode plots in the initial stage of immersion reveal an almost capacitive behaviour over the frequency range under consideration. The drop of the impedance modulus accompanied with an increase of the phase angle in the low frequency range after a few hours immersion point out the T<sub>g</sub> depression induced by the network plasticization by water molecules. The impedance modulus values at 0.1 Hz after 100

and 500 hours reflect the barrier properties of the coating at saturation in NaCl-1 % at 40°C. An efficient protection against corrosion is expected from this reference coating exhibiting a film resistance higher than 100 Mohm.cm<sup>2</sup> in the plasticized state as determined from the plateau in Bode-plot scans that occurred in low frequency regions.

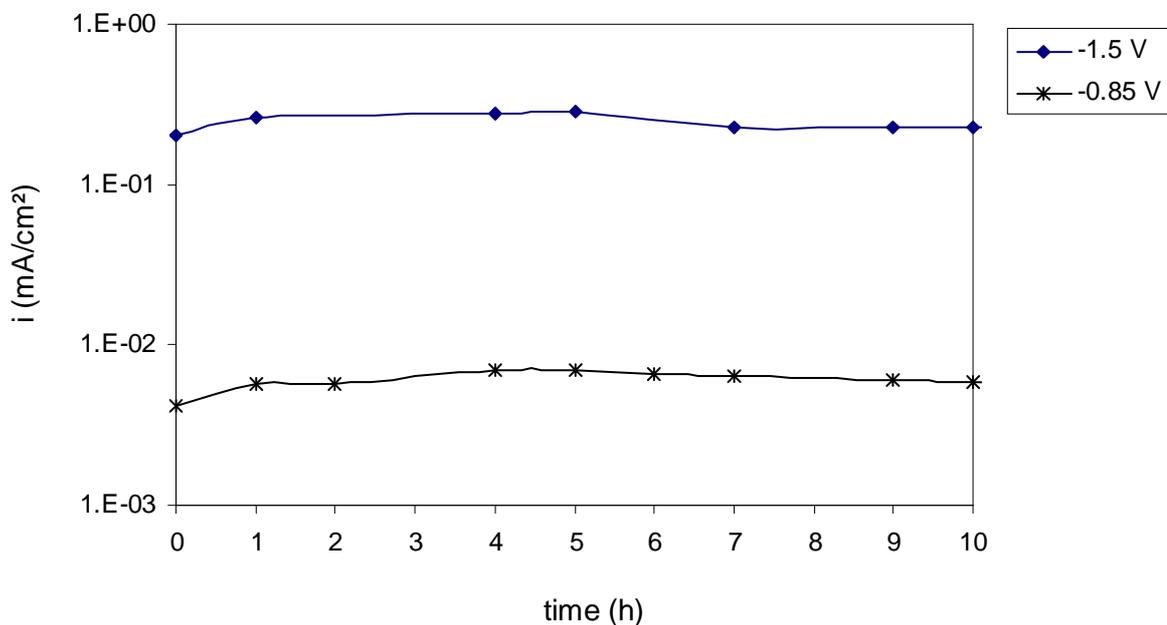
Figure 8 – Evolution of current density (with respect to defect area) with time for freshly scratched reference coatings (DFT = 200  $\mu\text{m}$ , exposed areas = 14  $\text{cm}^2$ ; defect areas = 0.01  $\text{cm}^2$ ) immersed in a solution of NaCl-1 % at 20°C under cathodic polarisation (-0.85 V and -1.5  $\text{V}_{/\text{Ag}/\text{AgCl}}$ ).

Attention was also focused on the current demand related to freshly scratched reference coatings submitted to cathodic protection. The evolution with time of the current density is illustrated on Figure 8 for reference coated panels (DFT 200 µm) immersed in NaCl-1 % solution at 20°C under -0.85 V and -1.5 V<sub>/Ag/AgCl</sub> cathodic protection. Coatings were scratched in situ just after immersion. The defect area has been taken as constant for calculating current density values (i.e. the current density is related to the estimated area of the defect, rather than to the whole exposed area) at a given time. It is clear from this graph that the current densities remain almost stable during the first hours whatever the polarisation level under consideration. Unchanged current level within the experience time suggests that the substrate area exposed to the electrolyte did not decrease nor enlarge itself - which would reveal some cathodic disbondment effect.

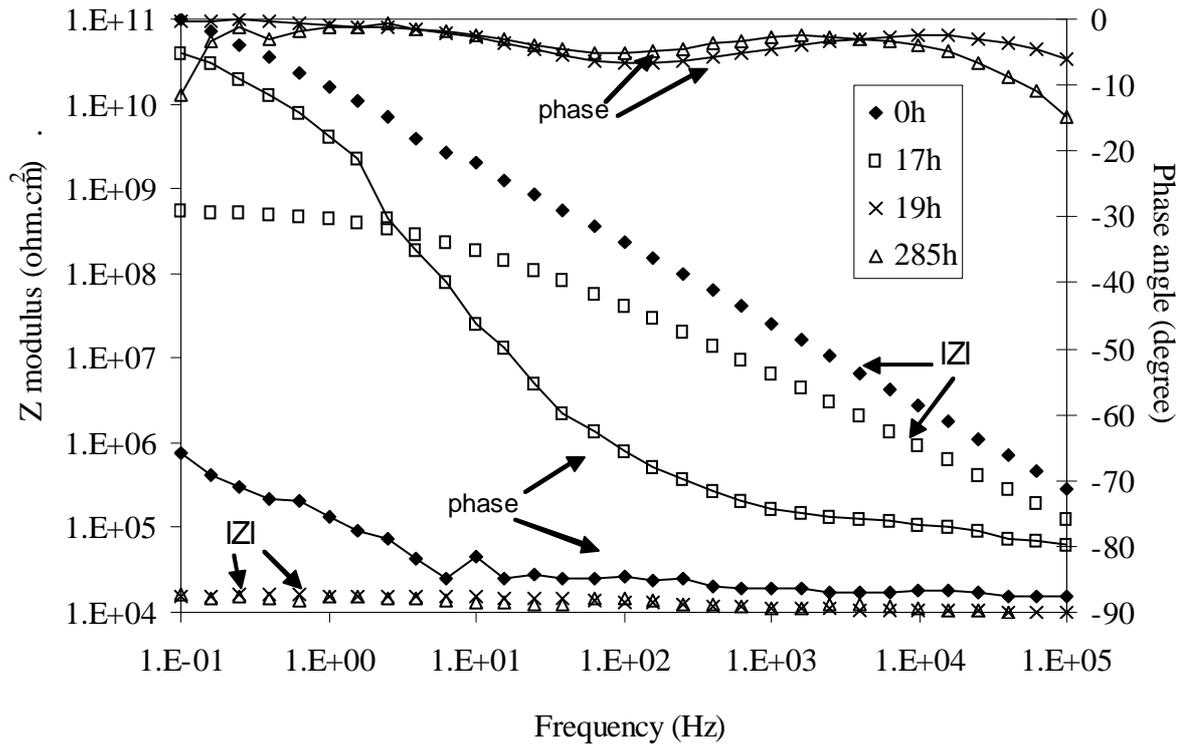
Figure 9 - Bode plots for the coating containing 30 % of inorganic film-formers (DFT = 650  $\mu\text{m}$ , exposed area = 75.4  $\text{cm}^2$ ) exposed to a solution of NaCl-1 % at 40°C under cathodic polarisation (-1.5  $\text{V}_{\text{Ag}/\text{AgCl}}$ ). Manual defect was intended in situ after 19 hours exposure.

The behaviour of a coating filled with 30 % (wt.) microcapsules containing a solution of MgSO<sub>4</sub> (DFT 650µm) was investigated by EIS during exposition to NaCl-1 % at 40°C under cathodic protection (-1.5 V<sub>/Ag/AgCl</sub>). A manual defect was intended in situ after 19 hours immersion. The evolution of the impedance modulus and phase versus frequency is plotted on Figure 9 after 0, 17, 19 and 285 hours. Note that the total exposed area was used for the curve normalisation in those four cases. Bode plots before intending a defect reveal a behaviour almost comparative to the reference material, namely capacitive over a broad frequency range and resistive in the low frequency range, with film resistance values taken at 0.1 Hz superior to 10<sup>8</sup> ohm.cm<sup>2</sup> but declining with exposure time due to water plasticization. This reveals that the incorporation of the microcapsules in the coating did not adversely affect its intrinsic barrier properties. In contrast, the behaviour of the freshly scratched coating is completely resistive with a pore resistance approaching 2.10<sup>4</sup> ohm.cm<sup>2</sup>. Unfortunately, this value remained unchanged when the inorganic filled- coating was exposed to an additional 20 days under cathodic protection, suggesting that the penetration of electrolytes through the defect areas was not restrained (Figure 10). This is also confirmed by the flat evolution with time of the current density (Figure 11) recorded on the coated specimen after the scratch was made (normalised with the defect area). This experiment shows that there is no evidence of recovery of the coatings' function as corrosion-preventing barriers thank to the addition of microencapsulated inorganic film-formers as studied. This result suggests that the choice of Mg<sup>2+</sup> as repairing agent was inappropriate to reduce the current demand and provide sealing effect. This may be due to the low concentration of the repair agent in microcapsules, but could also be related to the pH conditions which may not be alkaline enough to allow Mg(OH)<sub>2</sub> scale to form. The cathodic H<sub>2</sub> production may also be a factor of perturbation with respect to hydrodynamics.

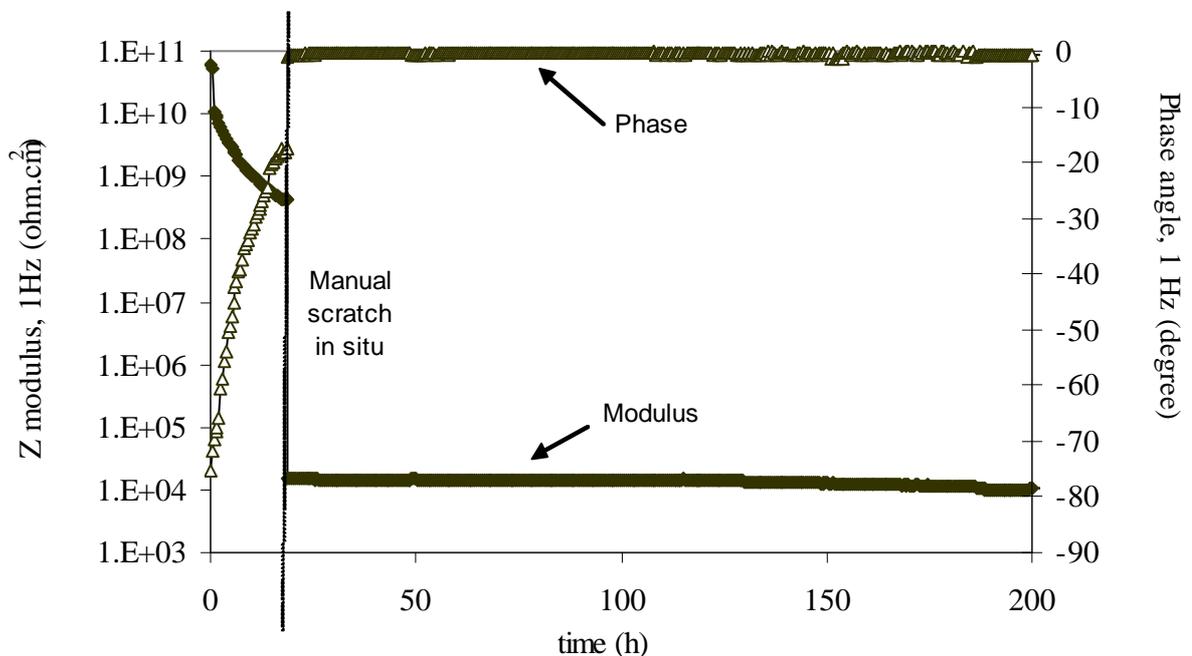
Figure 10 – Evolution with time of the impedance modulus and phase measured at 1 Hz for a coating (DFT ~ 650  $\mu\text{m}$ ) containing 30 % of inorganic film-formers and exposed to a solution of NaCl-1 % at 40°C under cathodic polarisation (-1.5  $\text{V}_{\text{Ag}/\text{AgCl}}$ ). Manual defect was intended after in situ 19 hours exposition.

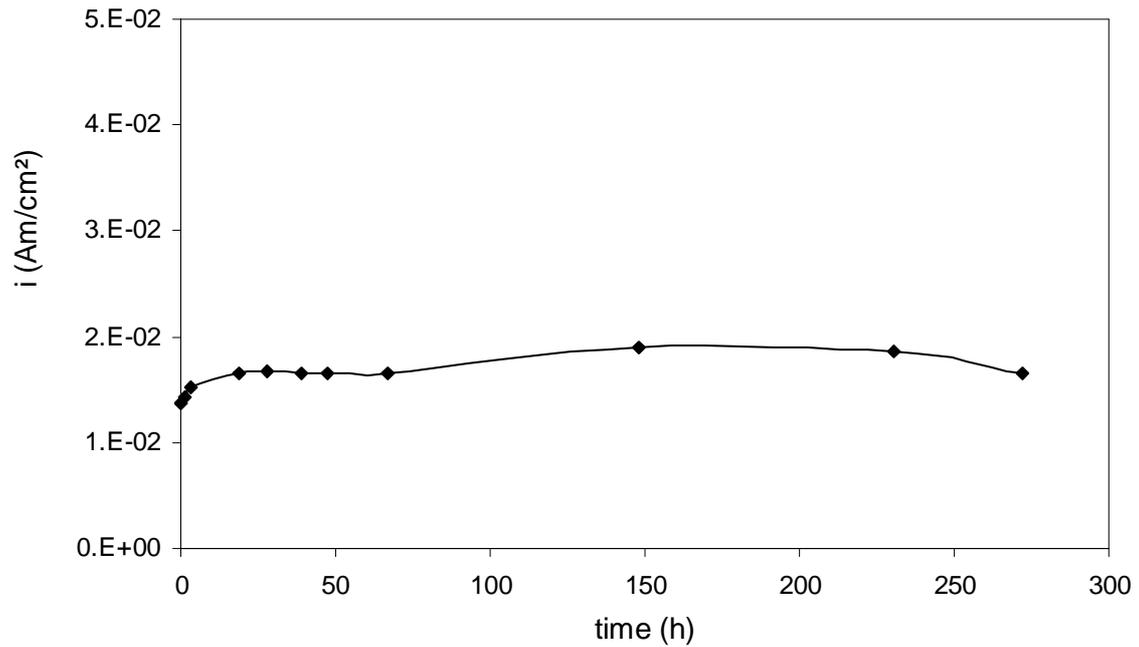
Figure 11 – Evolution of current density (with respect to defect area) with time for a freshly scratched coating containing 30 % of inorganic encapsulated agents (DFT ~ 650  $\mu\text{m}$ ) exposed to a solution of NaCl-1 % at 40°C under cathodic polarisation (-1.5  $V_{\text{Ag}/\text{AgCl}}$ ).

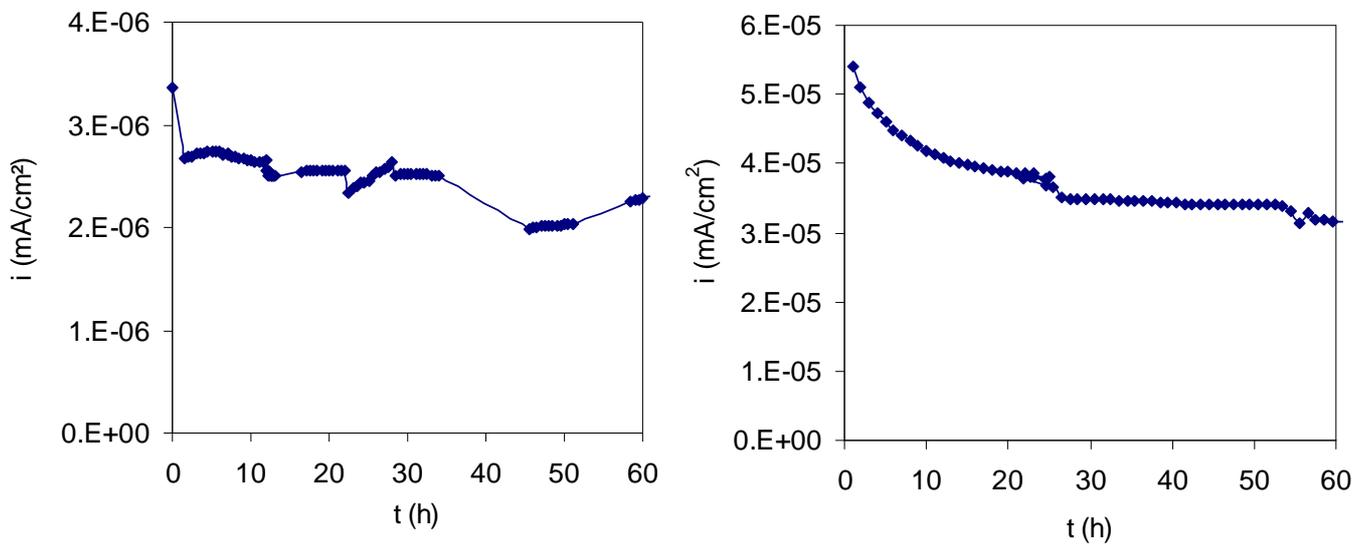
Figure 12 – Variation in current density (with respect to total exposed area) with the progress of film deposition at 20°C on bare steel panels under cathodic polarisation : -0.85  $V_{\text{Ag}/\text{AgCl}}$  (left); -1.1  $V_{\text{Ag}/\text{AgCl}}$  (right).

As a second step of the study, the focus concentrated on organic film-formers. It was first mandatory to investigate their ability to build a film on bare steel panels placed under cathodic polarisation with voltage as low as -0.85 V<sub>/Ag/AgCl</sub> (in comparison to

typical voltage applied for cathodic electrodeposition ranging from 5 V to 250 V). EPN-DEtOA (1:1.7 moles) adduct, prepared at 30°C in 24 hours of reaction time, was neutralised by acetic acid to produce the electrolytic composition used for the preparation of the electrolytic solution. A bare steel panel was immersed in the electrolytic composition (adduct acetate solution of concentration 20 % in deionised water) using the electrodeposition cell, and submitted to cathodic polarisation under  $-0.85\text{ V}/_{\text{Ag}/_{\text{AgCl}}}$  during three days at 20°C. A similar experiment was conducted at  $-1.1\text{ V}/_{\text{Ag}/_{\text{AgCl}}}$ . The variation in current density (with respect to the total area of conductive substrate immersed in the electrolytic bath) with the progress of film deposition has been presented in Figure 12. It is clear from both graphs that the current density drops during the initial period of deposition, meaning that the progress of the deposition of the adduct film (electrically non-conductive) reduced the passage of current. After the three days deposition time, the current density had almost reached steady values, called the residual current with respect to the conditions of application. It can also be concluded from both graphs that the polarisation voltage significantly influences the electrodeposition yield. Indeed, increasing the polarisation voltage markedly enhanced the current density drop and the current density values under  $-1.1\text{ V}/_{\text{Ag}/_{\text{AgCl}}}$  are one order of magnitude higher than those measured under  $-0.85\text{ V}/_{\text{Ag}/_{\text{AgCl}}}$  i.e. being the minimum voltage applied for efficient cathodic protection.

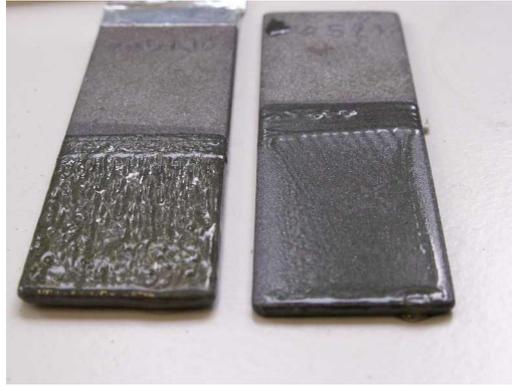
Figure 13 – Films electrodeposited on steel panels during 3 days exposure to a solution of organic film-former agents at 20°C under cathodic polarisation:  $-1.5 \text{ V}_{/\text{Ag}/\text{AgCl}}$  (left) ;  $-0.85 \text{ V}_{/\text{Ag}/\text{AgCl}}$  (right).

At the end of each experiment, freshly deposited film on the metallic panel was taken out of the electrolytic composition and rinsed under fresh water. Films were cured at room temperature during a 15 days period before the thickness of the dry and cured film was measured by using a magnetic film thickness gauge. As a matter of fact, a 150  $\mu\text{m}$  thick film was formed under  $-1.1\text{ V}/_{\text{Ag}/_{\text{AgCl}}}$ , whereas a thinner film of 35  $\mu\text{m}$  was deposited under  $-0.85\text{ V}/_{\text{Ag}/_{\text{AgCl}}}$  (Figure 13). By measuring the weight of paint applied during the experiment on each panel and the surface exposed, one could evaluate the electrodeposition yield at 20°C during 3 days in each case, namely 10  $\text{mg}/\text{cm}^2$  under  $-0.85\text{ V}/_{\text{Ag}/_{\text{AgCl}}}$  and 24  $\text{mg}/\text{cm}^2$  under  $-1.1\text{ V}/_{\text{Ag}/_{\text{AgCl}}}$ . This result confirmed that the electrodeposition yield increased at higher applied voltage, in agreement with the literature when applied voltage are below 25 V [27]. However, the films obtained under  $-1.1\text{ V}/_{\text{Ag}/_{\text{AgCl}}}$  was non-uniform and patchy in appearance. This was attributed to the hydrogen gas evolution at the cathode, hindering proper film deposition.

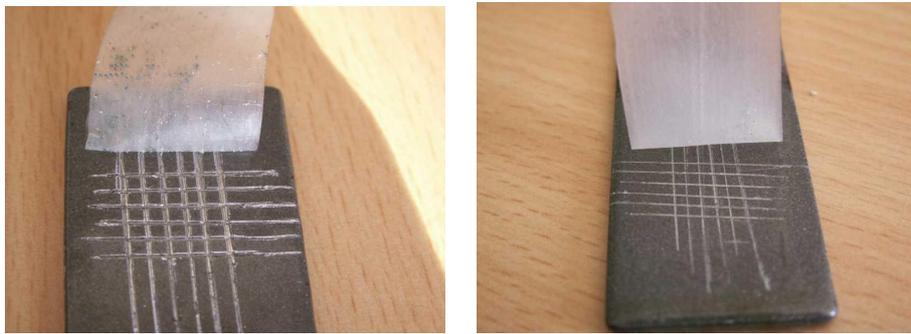
Figure 14 – Adhesion of films to steel panels measured by cross-hatch test after electrodeposition in an electrolytic bath during 3 days under cathodic polarisation and self-cure under air at room temperature during 15 days:  $-1.5 \text{ V}_{/\text{Ag}/\text{AgCl}}$  (left) ;  $-0.85 \text{ V}_{/\text{Ag}/\text{AgCl}}$  (right).

The adhesion properties were evaluated after curing the electrodeposited films for 15 days at room temperature (Figure 14). Both films showed 100 % adhesion, i.e. no square was lifted by the cross-hatched test. These results were indicative of good adhesion due to the presence of a large number of hydroxyl groups per mole of adduct (6, theoretically), assessing that water soluble self-curing EPN-DEtOA based adducts are capable of electrodeposition under cathodic polarisation.

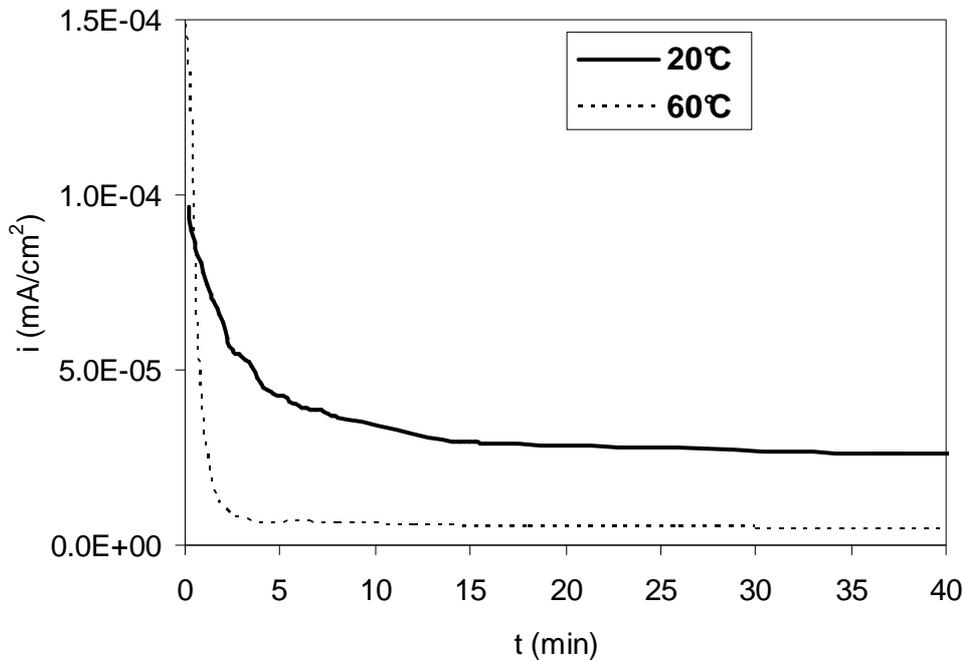
Figure 15 – Evolution of current density (with respect to defect areas) with time for freshly scratched coatings containing 30 % of dried organic agents exposed to a solution of NaCl-1 % at 20°C and 60°C under cathodic polarisation ( $-0.85 \text{ V}_{/\text{Ag}/\text{AgCl}}$ ).

To investigate the self-healing capability of aforementioned organic agents, the current demand of a freshly scratched coating filled with 30 % (wt.) dried acetate EPN-DEtOA (1/1.7 moles) adduct (DFT 300  $\mu\text{m}$ , exposition area = 20  $\text{cm}^2$ , defect area  $\approx 0.015\text{ cm}^2$ ) was monitored with time during exposition to NaCl-1 % at 20°C under cathodic polarisation ( $-0.85\text{ V}/_{\text{Ag}/_{\text{AgCl}}}$ ). A similar experiment was conducted at 60°C on a freshly scratched coating filled with 30 % of organic agent (DFT 800  $\mu\text{m}$ , exposition area = 14  $\text{cm}^2$ , defect area  $\approx 0.005\text{ cm}^2$ ). The evolution of the current density with respect to the defect area is plotted versus time on the Figure 15 for both temperatures. Interestingly, the current density drops with the time whatever the temperature, which reveals that the substrate went on sealing off itself, and consequently reduced the passage of current.

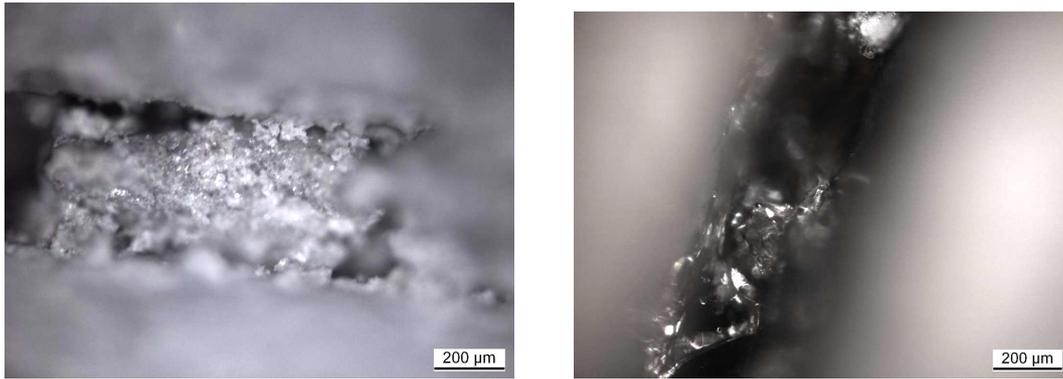
Figure 16 – Films deposited in a scratched coating area immersed in a solution of NaCl-1 % under cathodic polarisation ( $-0.85 V_{/Ag/AgCl}$ ) during 40 hours: 20°C (left) ; 60°C (right).

Since the current demand was shown to be constant for the reference coating (i.e. without active fillers) immersed and scratched under similar conditions, this finding demonstrates that dried organic agents used as fillers in coatings under cathodic polarisation contribute to restrain the penetration of electrolytes through the defect area, and consequently reduce the demand in current. The final current density reached  $3.10^{-5}$  mA/cm<sup>2</sup> at 20°C under -0.85 V/Ag/AgCl for the scratched coating containing organic fillers, which was one decade above the plateau value of  $2.10^{-6}$  mA/cm<sup>2</sup> reached in the scratched reference coating immersed under similar conditions. This comparison indicates that the electrodeposition yield of adducts embedded in coatings is somewhat lower than when they constitute the electrolytic solution; however, progress could be expected thank to a smaller filler design and to an optimised coating formulation with respect to the defect geometry (width and volume) [28]. Kinetics of current drop was shown to be faster at higher temperature as one can expect from cathodic electrodeposition related to thermally activated diffusion process and chemical reactions. In addition, the initial current density value is higher at 60°C, reflecting the higher mobility of conductive species involved in the passage of current due to thermal activation. The microphotographs of the defect areas after cathodic electrodeposition shown on Figure 16 confirmed the growth of a film with apparent resin deposited within the scratch groove. However, it is not easy to discuss further from these pictures since the expected deposited films are transparent (clear coats).

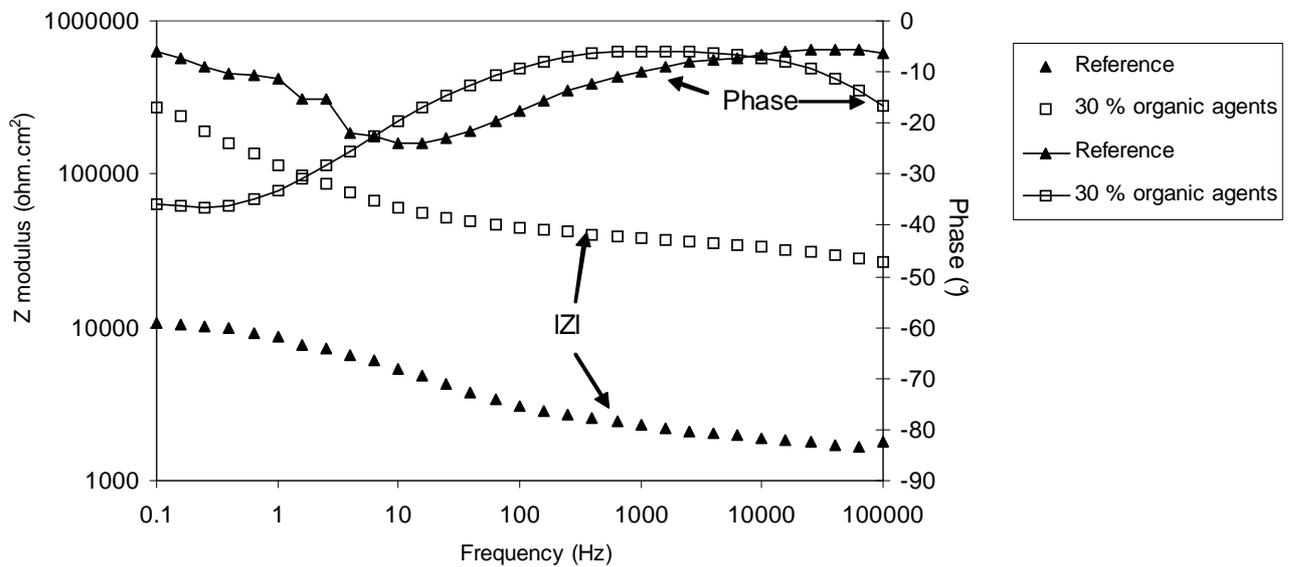
Figure 17 – Bode plots for scratched coatings exposed to a solution of NaCl-1 % at 20°C: reference (DFT = 200  $\mu\text{m}$ , exposed area = 14  $\text{cm}^2$ , defect area = 0.01  $\text{cm}^2$ ) and coating containing 30 % of organic film-formers exposed 40 hours to a solution of NaCl-1 % at 60°C under  $-0.85 V_{/Ag/AgCl}$  CP and cured 15 days at ambient temperature (DFT = 800  $\mu\text{m}$ , exposed area = 14  $\text{cm}^2$ , defect area = 0.005  $\text{cm}^2$ ) .

The study then shifted to assessing the ability of the partly sealed scratched coating to protect the underlying steel against corrosion. Bode plots were obtained on the scratched coating after 40 hours exposition at 60°C under CP, 15 days curing out of the solution at ambient temperature, then immersion again for the testing (Figure 17). Bode diagrams of the scratched reference coating are also presented but defects were not similar in size, thus impedance moduli given with respect to the exposition area could not be used for comparison purpose on the contrary to the phase plots. In the low frequency region, the phase of the scratched reference coating remained fully resistive whereas the phase of the scratched coating filled with organic agents was significantly diminishing, suggesting that the formation of an organic film within the defect contributed to the barrier effect. However, impedance values remained below the outstanding properties of the intact coating, which indicates that the efficiency of organic film-formers should be further improved to get 100 % self-healing capabilities, i.e. recover initial properties.
